# Ruptured Hose

EPSC Learning Sheet - Feb 2022

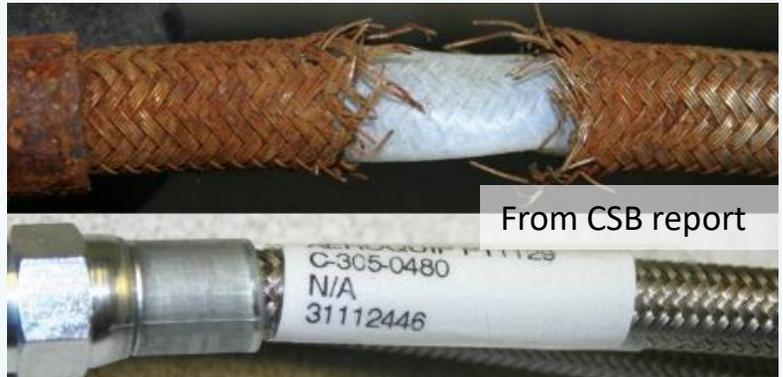
Phosgene was unloaded from 1-ton cylinders through a flexible hose (PTFE braided with stainless steel) to a chemical process.

Under the label, the hose braiding corroded. The weak hose ruptured, spraying a nearby operator with Phosgene.

- Phosgene permeates through PTFE causing high HCl concentrations under the label that fully corroded the stainless-steel braiding. Avoid permeating plastics and assure braiding material is resistant (SS-316 is incompatible with HCl).
- Inspect hoses according a PM schedule and replace in time.
- When deviations like corrosion are observed (see photo), take appropriate action on all similar hoses.
- Hoses full of liquid Phosgene could be blocked in, causing increased pressure during temperature rise. Discuss this hazard in PHA studies and explain this to operators.
- Use fixed piping (avoid hoses) for very toxic chemicals.

**Avoid flexible hoses with very toxic chemicals**
